Rock Mechanics Investigations at the Lucky Friday Mine

1. Instrumentation of an Experimental Underhand Longwall Stope

**By T. J. Williams, J. K. Whyatt,
and M. E. Poad**

UNITED STATES DEPARTMENT OF THE INTERIOR

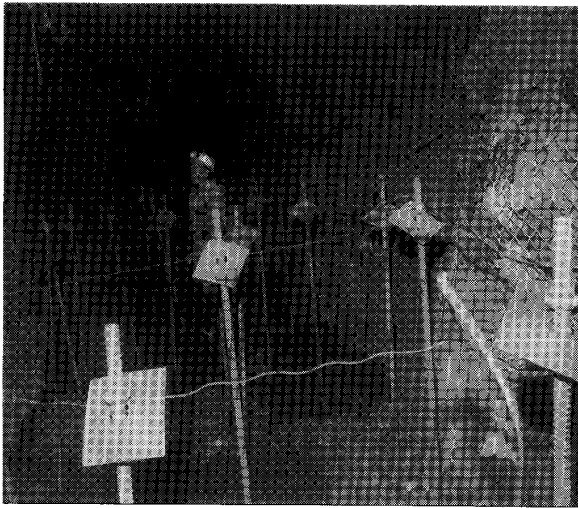
Figure 14.—Preparing Dywidag bolts for sandfill.

A mine shutdown in January 1987 provided mine engineers with an opportunity to modify the fill reinforcement system by replacing cable slings with 6-ft-long Dywidag bolts. These bolts were installed vertically on 2- to 3-ft centers and behaved in a manner similar to rebar in concrete (fig. 14). The bottom end of each bolt was driven through wire mesh into loose muck on the floor. (The wire mesh was eventually eliminated in later cuts without any problems.) A nut and a plate were then placed on the top of the bolt to serve as an anchor in the fill. As the next cut was mined, the bottom ends of the bolts were exposed. At this time, a second set of plates and bolts were installed to tension the rebar and provide anchors for fencing. Fencing extended along the entire back and down the stope walls to within 1.5 ft of the bottom. Split-Set bolts were used to fasten the fencing to stope walls. The fencing protected miners from fly rock and localized rock bursts (fig. 15).

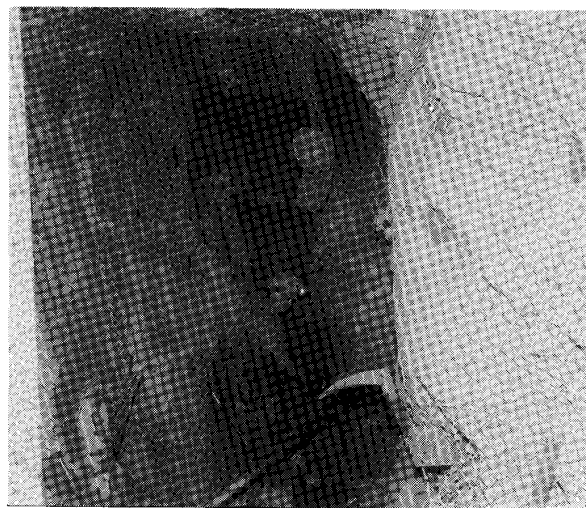
Figure 15.—Hanging chain link fencing for overhead protection.
